# THE • INTERIOR • BUILDING ITS • ARCHITECTURE • AND • ITS • ART

PRESERVATION CASE STUDIES

David W. Look, AIA  
Carole L. Perrault

U.S. Department of the Interior  
National Park Service  
Preservation Assistance Division  
1986

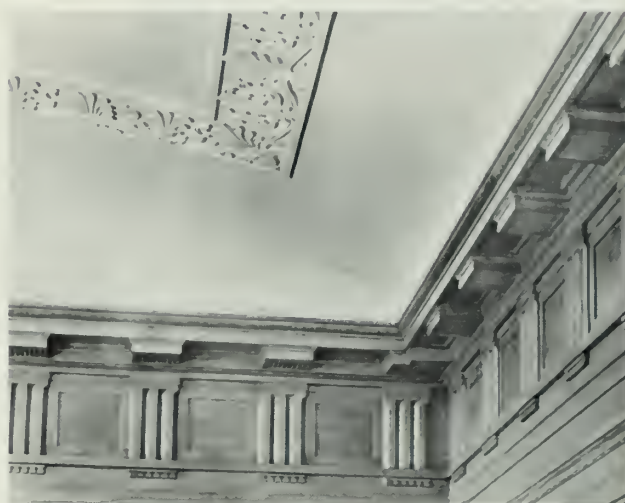
109

109. DORIC FRIEZE, SOFFIT, AND ANTHEMION BAND, OFFICE OF THE SECRETARY, ROOM 6156, SUITE 6000, WING 6100 WEST, SIXTH FLOOR. The Doric frieze and soffit are oak, the ceiling is acoustic plaster, and the lunnette and anthemion band (Model No. 320) are hard plaster. Brooks Photographers, Bethesda, Maryland, 1976, HABS Collection.

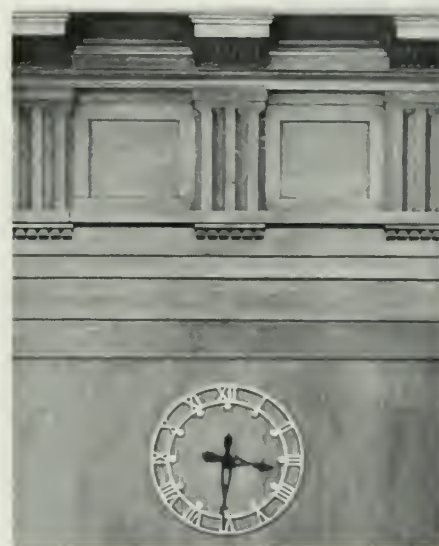
110

110. BRONZE CLOCK, OFFICE OF THE SECRETARY, ROOM 6156, SUITE 6000, WING 6100 WEST, SIXTH FLOOR. The built-in clock has its works hidden behind the oak paneling. Brooks Photographers, Bethesda, Maryland, 1976, HABS Collection.

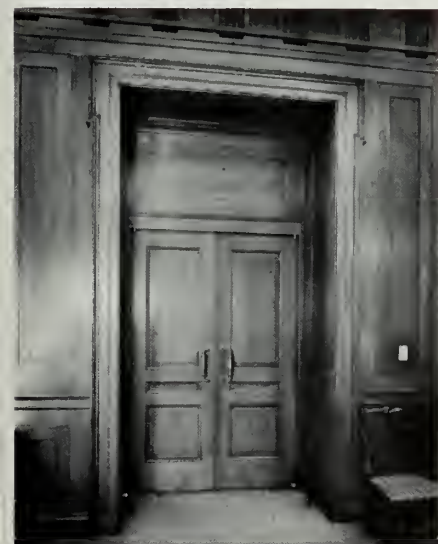
111

111. DOUBLE DOORS, OFFICE OF THE SECRETARY, ROOM 6156, SUITE 6000, WING 6100 WEST, SIXTH FLOOR. The door recess is paneled and the door surround is cross-topped. Brooks Photographers, Bethesda, Maryland, 1976, HABS Collection.

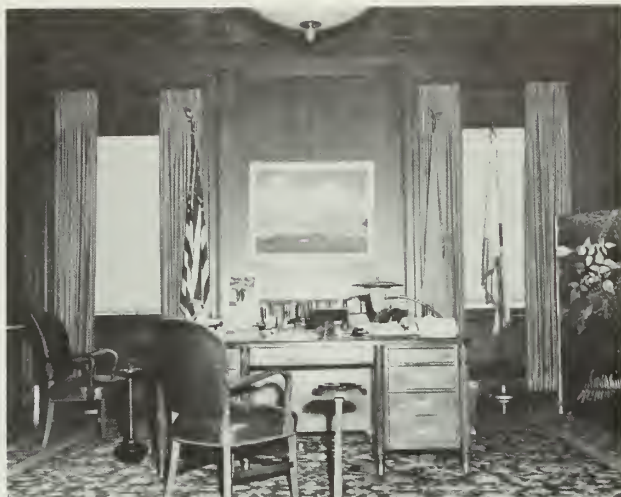
112

112. SOUTH WALL, OFFICE OF THE SECRETARY, ROOM 6156, SUITE 6000, WING 6100 WEST, SIXTH FLOOR. View looking south toward Secretary Udall's desk. Note that the chandelier still had its pineapple-like ornament and alabaster bowl with concentric rings (see Figs. 115 and 280). The chandelier was modified in 1964 to install down lights. National Park Service Historic Negative Collection (photographer unknown), 1963.

The south wall also has two windows. These windows face onto Constitution Avenue and the Mall (Fig. 112).

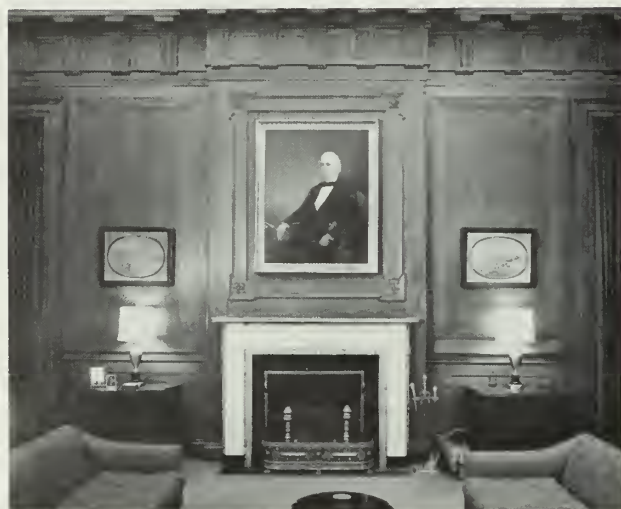
113. WEST WALL, OFFICE OF THE SECRETARY, ROOM 6156, SUITE 6000, WING 6100 WEST, SIXTH FLOOR. View of west wall between the glazed doors. Brooks Photographers, Bethesda, Maryland, 1976, HABS Collection.

The west wall has two pairs of glazed doors (not original) opening onto a tiled terrace which overlooks the Civil Service Commission Building. Between these doors is a marble fireplace (Figs. 113 and 114). The mantel is constructed of three kinds of marbles. The face of the mantel is Vermont White Statuary Marble with a polished finish; the mantel shelf, sides, and firebox surround are Vermont Livido Marble with polished finish; and the hearth is Virginia Royal Black Marble with both a honed and polished finish. The design of the mantel, (Model No. 21, Fig. 278), was copied from one of the mantels in the Old Senate Chamber of the Capitol. The chimney breast features an oak tabernacle frame with carved moldings and filled with a Greek fret design with crosstetted border and square rosettes in the corners. An oil portrait of

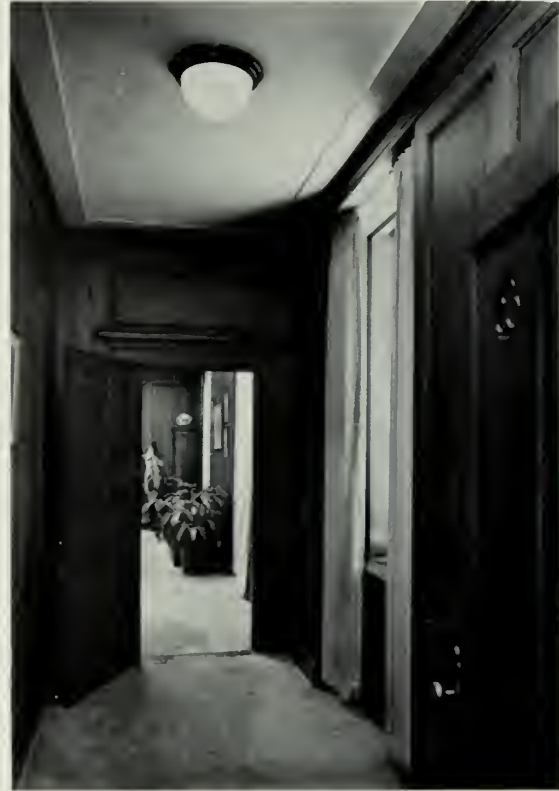
118

118. SUPPORT STAFF ROOM, (FORMERLY STUDY) ROOM 6154, SUITE 6000, WING 6100 WEST, SIXTH FLOOR. View looking toward the northwest. Note the hidden door in the paneling and the trefoil on the other doors. Brooks Photographers, Bethesda, Maryland, 1976, HABS Collection.

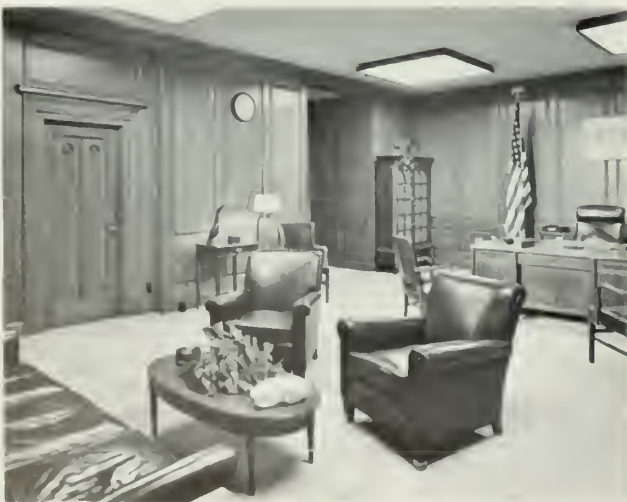
120

The floor is covered with wall-to-wall carpeting (Fig. 120). The original flooring was white oak laid in a herringbone pattern.

Room 6144 (Fig. 120, formerly the Secretary’s Private Office) is two bays long and over one bay wide (Fig. 101). It is wider than Room 6154 because the Wing Corridor shifts off center along the offices of the assistants to the Secretary. Between the Wing Corridor and Room 6144 is a small vestibule formed by the large closet of Room 6144 and the small closet of Room 6142. Two new doors were cut through the west wall of Room 6144 when Room 6154 was renovated, but there is no evidence that the floor plan has ever changed.

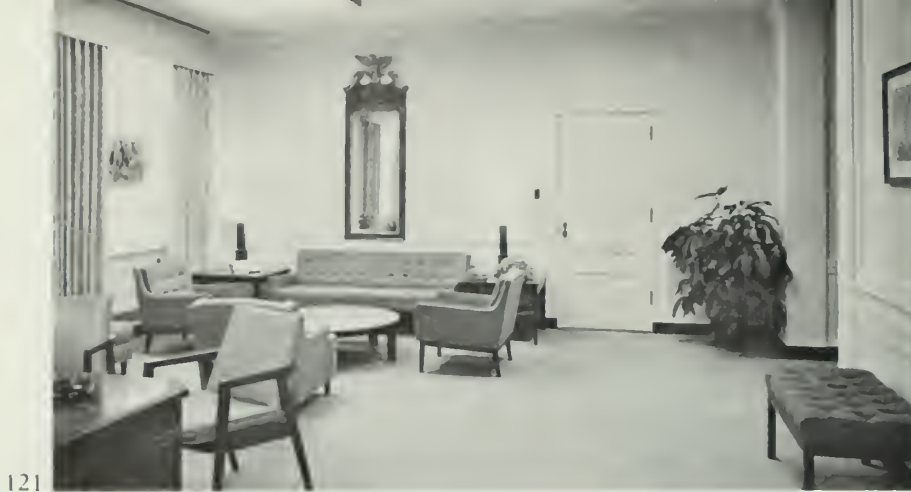
121, ROOM 6140, SUITE 6000, WING 6100 WEST, SIXTH FLOOR. View looking toward the west. An assistant to the Secretary occupies this office. This office has flush plaster panels with wooden molded stiles and rails both above and below the chair rail. Brooks Photographers, Bethesda, Maryland, 1976, HABS Collection.

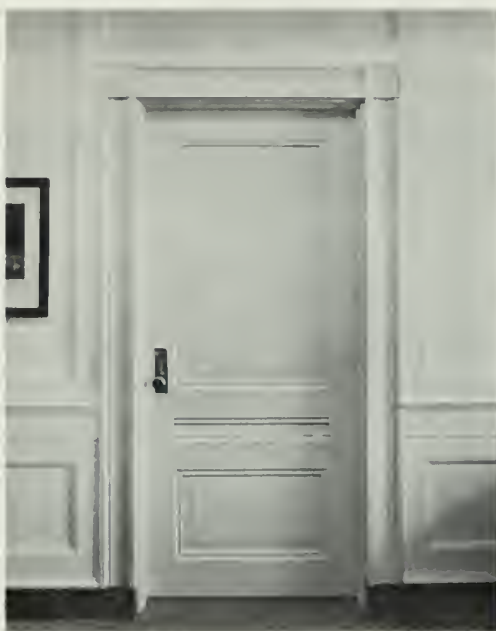
122. DOOR, ROOM 6136, SUITE 6000, WING 6100 WEST, SIXTH FLOOR. The wooden doors and surrounds of Rooms 6136, 6140, and 6142 are identical. Brooks Photographers, Bethesda, Maryland, 1976. HABS Collection.

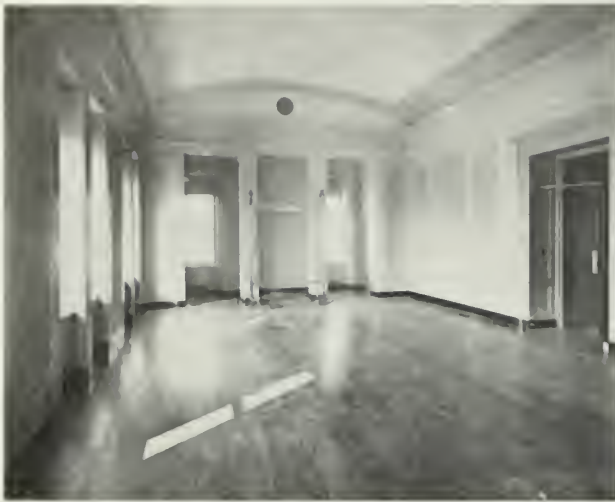
125

125. SECRETARY'S CONFERENCE ROOM BEFORE REMODELING, ROOM 5160, WING 5100 WEST, FIFTH FLOOR. This photograph was taken about 1936 and shows the original walnut floors, plaster paneled walls, columns, and lamps. Public Building Service, Photo No. 121-BCP-136A-19 in the National Archives.

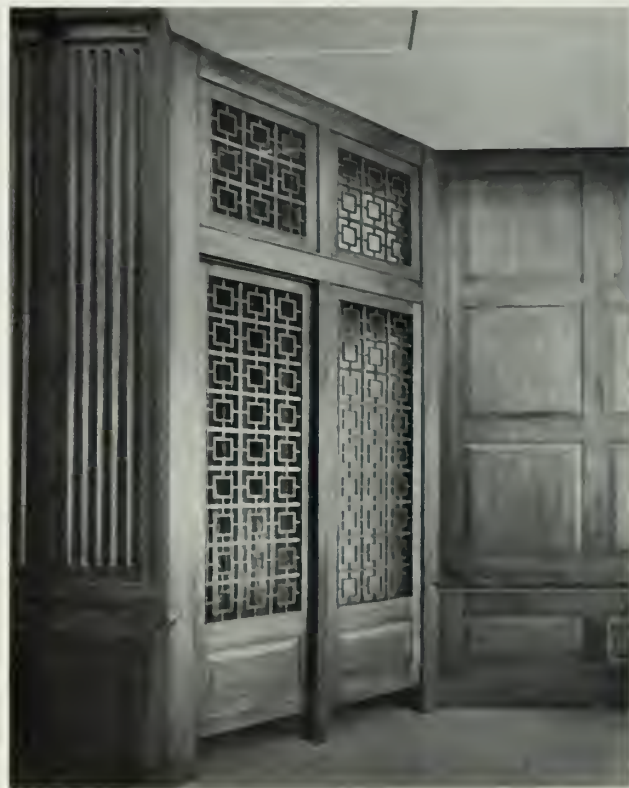
127

127. DETAIL OF WALLS, SECRETARY'S CONFERENCE ROOM, ROOM 5160, WING 5100 WEST, FIFTH FLOOR. View of walnut paneling, pilasters, and grille (none are original). The design motif of the grilles was copied in 1964 from the iron gates to the courtyards (see Fig. 28). Brooks Photographers, Bethesda, Maryland, 1976, HABS Collection.

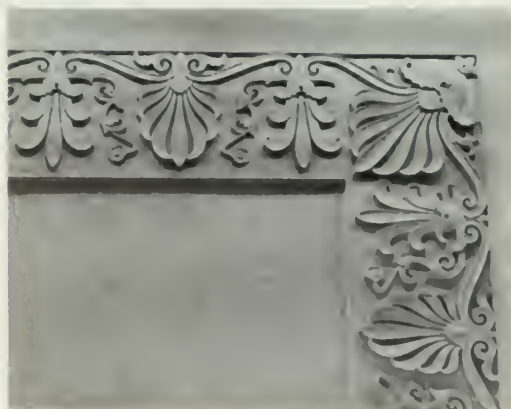
128

128. DETAIL OF CEILING, SECRETARY'S CONFERENCE ROOM, ROOM 5160, WING 5100 WEST, FIFTH FLOOR. The anthemion band is Model No. 319 (see Fig. 277). Brooks Photographers, Bethesda, Maryland, 1976, HABS Collection.

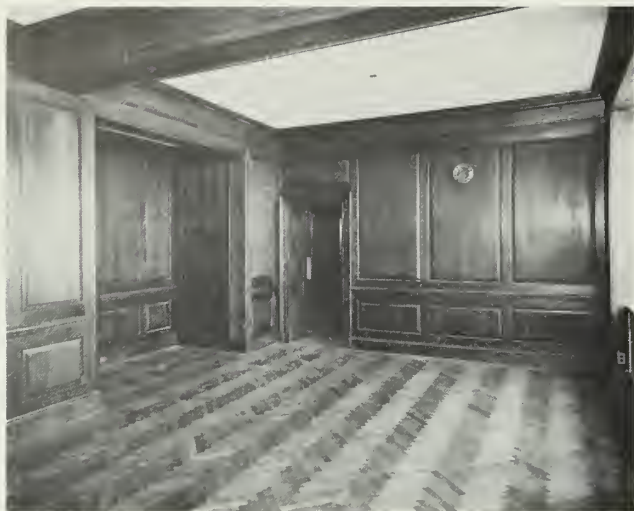
129

129. LARGE EXECUTIVE DINING ROOM, WING 5100 WEST, FIFTH FLOOR. This photograph of Room 5151 was taken during the final stages of construction in 1936. It was substantially finished except for the installation of chandeliers and wall sconces. Room 5151 was designed for the dining use of the Secretary, the Under-Secretary, Assistant Secretaries and their guests. Room 5159, which is smaller, was designated as the Secretary's Dining Room and reserved for the Secretary and his guests exclusively. Public Buildings Service, Photo No. 121-BCP-136A-20 in the National Archives, Washington, D.C.

The walls of Room 5151 are oak with raised panels and chair rails. The paneling and woodwork have been acid stained to a soft brown "English oak" color. The baseboard is oak. The bronze clock on the west wall is similar to those in the Reception Area of the Secretary's Suite. The metal ventilation units under the double windows are grained to match the oak paneling. Window and door surrounds have mitered corners.

The ceiling of the large Executive Dining Rooms is acoustic plaster with simple wood cornice and a wood covered beam between bays. The original chandeliers are bronze with a frosted glass bowl (Model No. 334, not illustrated). The bronze cap at the ceiling is embellished with overlapping laurel leaves. The bowl is supported by a reeded rod. The bronze rim of the bowl is reeded and wrapped at six points with a ribbon. The model number of the bronze sconces in the alcove has not been located. The vestibule has a round bronze lighting fixture with an etched, frosted glass bowl mounted flat against the ceiling (Model No. 343, not illustrated). The bronze rim is reeded and the etched pattern is of a stylized ivy design.

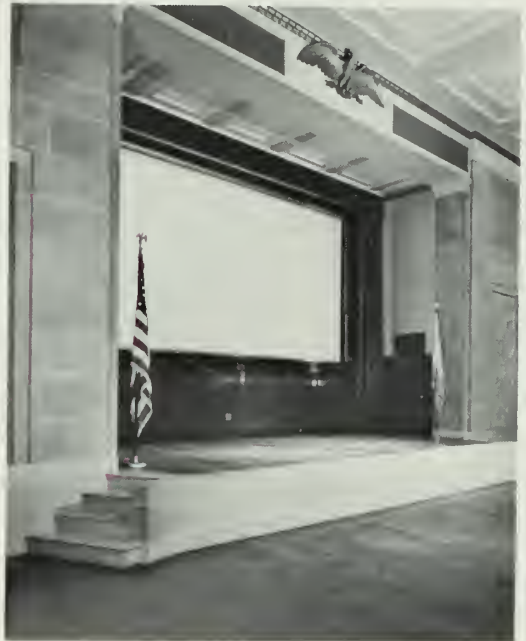
137

137. STAGE, AUDITORIUM, WING 1100 EAST, FIRST FLOOR. The oak floor is laid in a herringbone pattern. The wainscotting is walnut. The hard plaster eagle is Model No. 309 and the Doric molding is Model No. 314 (see Fig. 275). Brooks Photographers, Bethesda, Maryland, 1976, HABS Collection.

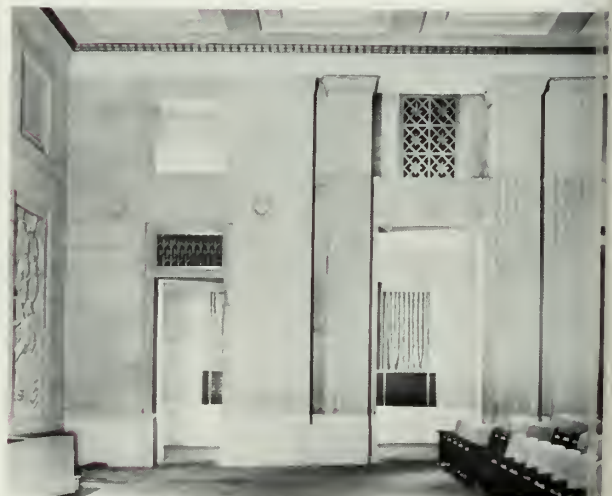
138

138. TYPICAL BAY AND END BAY, AUDITORIUM, WING 1100 EAST, FIRST FLOOR. The bay is recessed behind the surface of the end bay and is flanked by fluted limestone pilasters. The bronze grille above the portal of the end bay is Model No. 114 (see Fig. 286). Brooks Photographers, Bethesda, Maryland, 1976, HABS Collection.

to the side aisles (Fig. 138). Each pier is a double set of pilasters with a simple capital of an anthemion band, above a bead-and-reel molding (Model No. 310, Figs. 139 and 274).

The four corner bays of the Auditorium (Fig. 138) do not have pilasters and consist of a smaller opening connecting the nave and side aisles. Centered between the openings and seals is a bronze grille

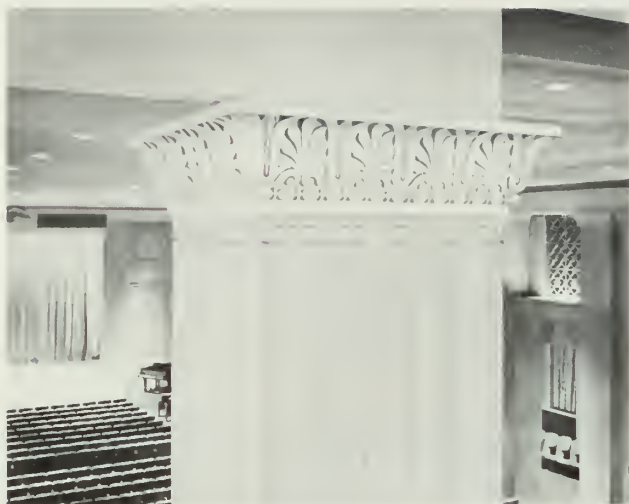
139

**139. COLUMN CAPITAL, AUDITORIUM, WING 1100 EAST, FIRST FLOOR.** The design of the capitals for both the columns and pilasters is Model No. 310 (see Fig. 274). Brooks Photographers, Bethesda, Maryland, 1976, HABS Collection.

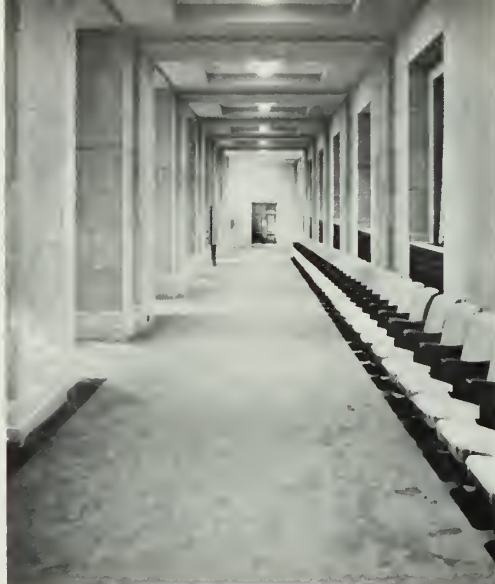
142

**142. SOUTH SIDE AISLE, AUDITORIUM, WING 1100 EAST, FIRST FLOOR.** View looking east toward the backstage area. The Doric molding around the recessed ceiling panels is Model No. 313 (see Fig. 275). Brooks Photographers, Bethesda, Maryland, 1976, HABS Collection.

**The Side Aisles:** The ceiling of the side aisles consists of a series of square plaster panels (one per bay) with a shallow, plain plaster beam between bays (Fig. 142). Each square has a deeply recessed panel bordered by a hard plaster Doric molding (Model No. 313, Fig. 275), and a hard plaster recessed band. The innermost square is acoustic plaster with a round incandescent fixture. In the center of the fixture is a conical spot down-light.

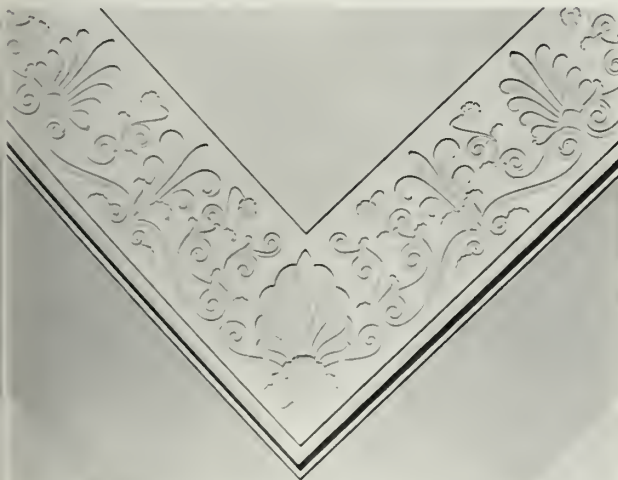
146

**146. CEILING, AUDITORIUM, WING 1100 EAST, FIRST FLOOR.** The hard plaster anthemion band is Model No. 312 (see Fig. 275). Brooks Photographers, Bethesda, Maryland, 1976, HABS Collection.

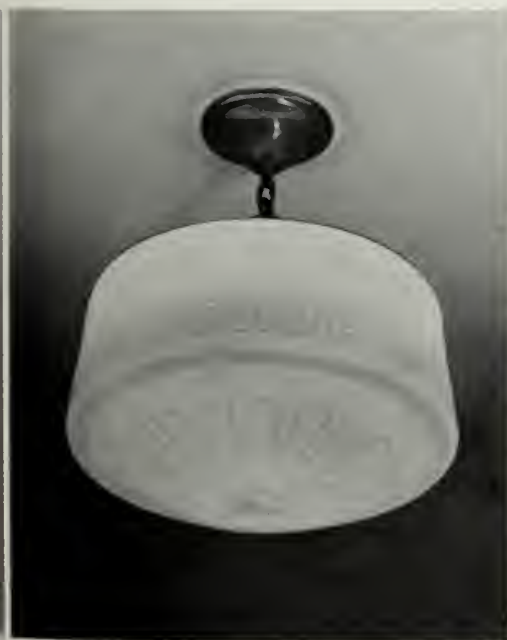
147

**147. HANGING INCANDESCENT LAMP, BACKSTAGE CORRIDOR, AUDITORIUM WING 1100 EAST, FIRST FLOOR.** This lighting fixture is similar to the original fixtures in the South Penthouse (see Fig. 188). Brooks Photographers, Bethesda, Maryland, 1976, HABS Collection.

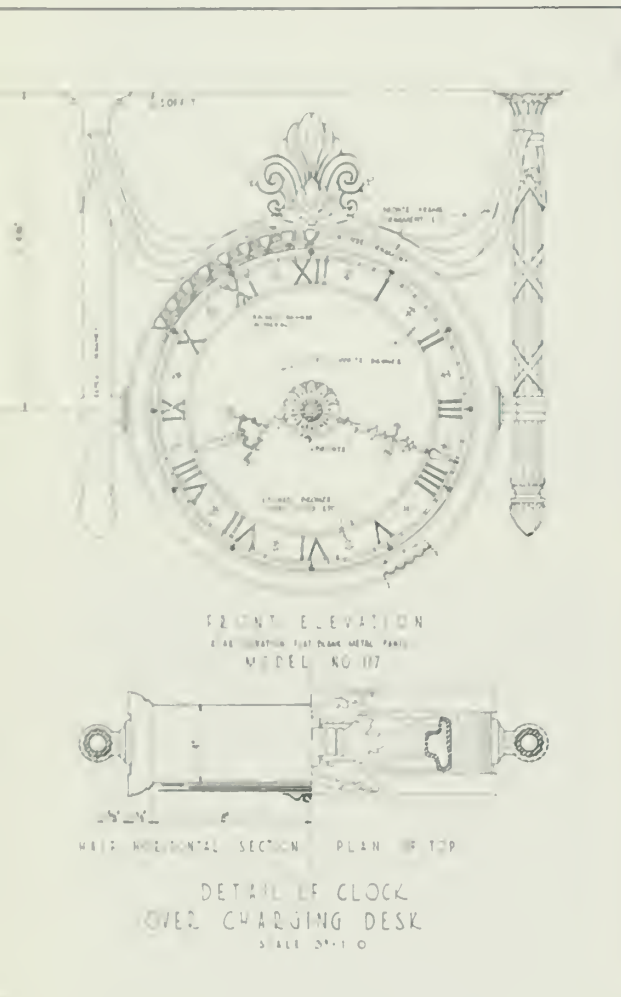
148. DETAILS OF CLOCK, LIBRARY, WING 1100 WEST, FIRST FLOOR. Model No. 117 is the bronze clock in the Library. The drawing shows the front elevation, section, and plan views (see Figs. 155 and 285). Detail of Drawing No. 227, by Owings, Peele, and Tucker, May 1, 1935. Document stored at the National Record Center, Suitland, Maryland, Record Group 121-76-301, Box 86, No. DC 0020 ZZ 202.

The original, built-in charging desk was in the middle bay of the Circulation Alcove (Figs. 150 and 151). The charging desk was moved in 1966 to the main door next to the South Lobby. An ornate bronze clock (Fig. 155) is suspended from the ceiling over the location of the original charging desk. This clock was specially designed for the Reading Room (Model No. 117, Figs. 148 and 285).

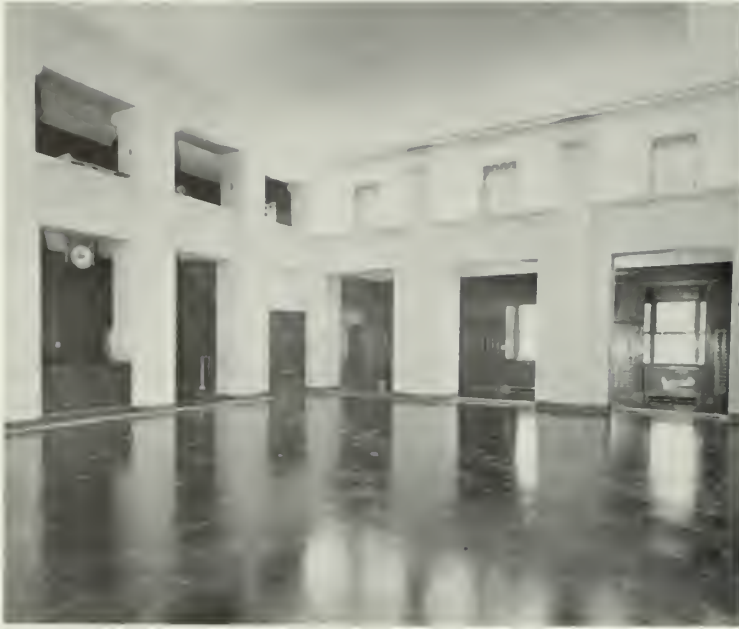
151

151. CORK FLOORING, READING ROOM, LIBRARY, WING 1100 WEST, FIRST FLOOR. The photograph was taken during the final stages of construction in 1936. This view, looking northwest, shows the checkerboard pattern of contrasting light and dark cork tile. Public Buildings Services, Photo No. 121-BCP-136A-14 in the National Archives, Washington, D.C.

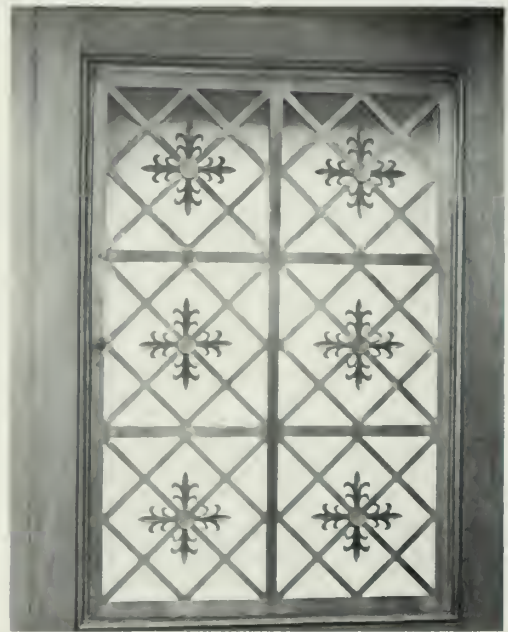
154

Hinged ornate bronze grilles (Model No. 118, Fig. 154) cover the windows in the blind galleries over the Card Index Alcove and the Reference Alcove. The design of the grilles is a modified Roman grate

At the south end of both galleries, and above the stairs, are windows with bronze grilles. The grilles have the same pattern as those in the blind gallery on the north and south sides of the Reading Room (Fig. 154). Below the windows on the south end of the two galleries are metal heating and air-conditioning units, which are grained to match the walnut paneling.

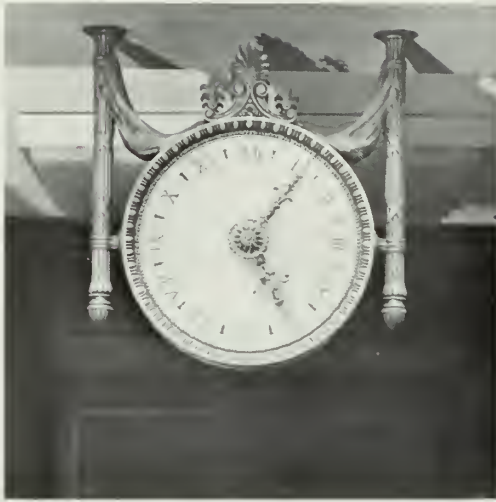
155

155. BRONZE CLOCK, READING ROOM, LIBRARY, WING 1100 WEST, FIRST FLOOR. This ornate bronze clock, Model No. 117, was especially designed for the Reading Room (see Figs. 148 and 285). Brooks Photographers, Bethesda, Maryland, 1976, HABS Collection.

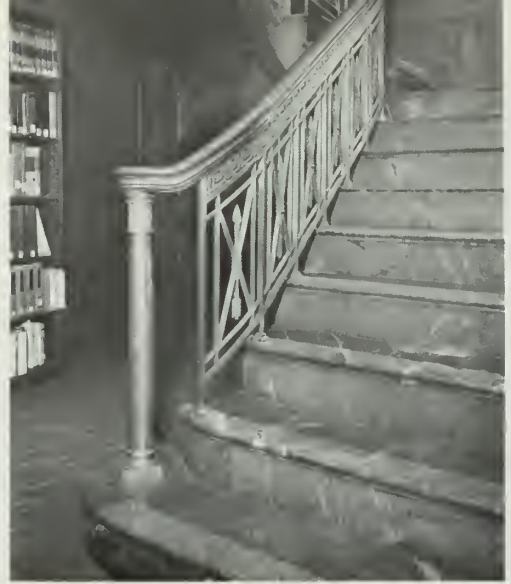
156

156. STAIRS N, LIBRARY, WING 1100 WEST, FIRST FLOOR. The stairs, Model No. 119, has Cardiff green steps, bronze railing, and a walnut handrail (Fig. 286). Brooks Photographers, Bethesda, Maryland, 1976, HABS Collection.

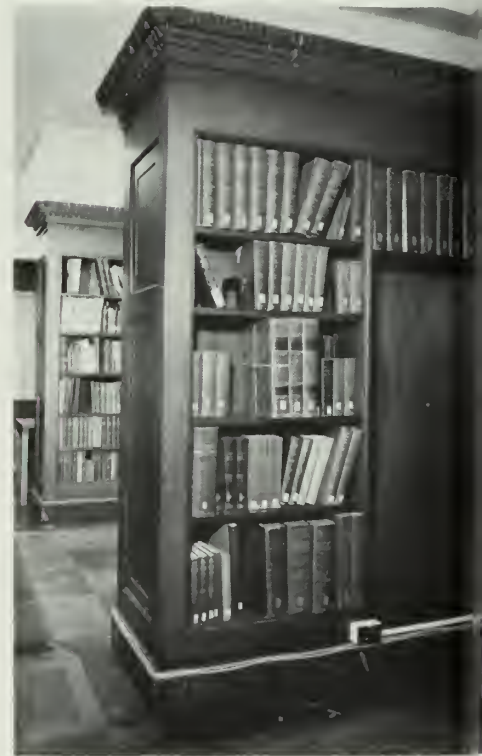
157

157. EAST GALLERY, LIBRARY, WING 1100 WEST, SECOND FLOOR. The galleries have built-in walnut bookcases and their original cork flooring with black marble borders. Brooks Photographers, Bethesda, Maryland, 1976, HABS Collection.

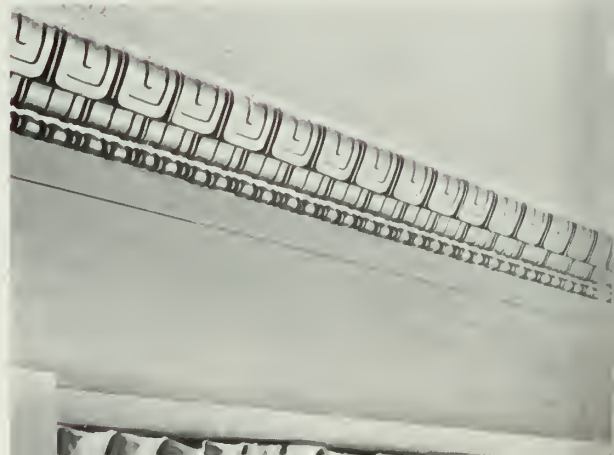
158

158. DETAIL OF MOLDING AND GRAINING, EAST GALLERY, LIBRARY, WING 1100 WEST, SECOND FLOOR. The plastered beam and plaster Doric molding (Model No. 317, see Fig. 274) are grained to match the walnut paneling. Brooks Photographers, Bethesda, Maryland, 1976, HABS Collection.

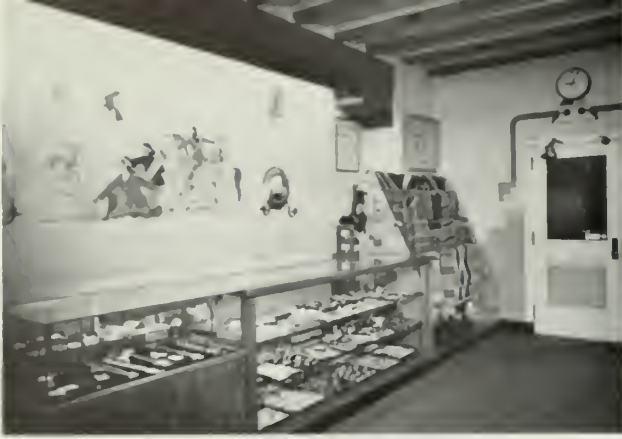
168. NORTH SALES AND DISPLAY ROOM (1023), ARTS AND CRAFTS SHOP, MAIN CORRIDOR, FIRST FLOOR. View of shop looking southwest. Note the mural by Gerald Nailor on the south wall (Fig. 211), the painted wainscot, and the painted design surrounding the entrance door. Brooks Photographers, Bethesda, Maryland, 1976, HABS Collection.

The north room is the most highly embellished of the two display rooms (Fig. 168). The entrance door

A black slate 5-inch baseboard surrounds the room, and the walls are covered with canvas. Above the baseboard is a painted wainscot, ochre in color. The wainscot terminates in a step-like design at the entrance door (Fig. 168). The walls above the wainscot are painted beige, providing a background for the mural decoration. Overhead the main corridor door and extending on each side of the door to the wainscot is a multicolored rainbow design. Both the north and south walls are decorated with murals painted by two Indian artists. (For a description of murals, see Chapter VIII.)

In addition to the sconces, the north room lighting is accomplished indirectly by fluorescent tubes, positioned below the side wall decorative beams, behind a shield (Figs. 168 and 169).

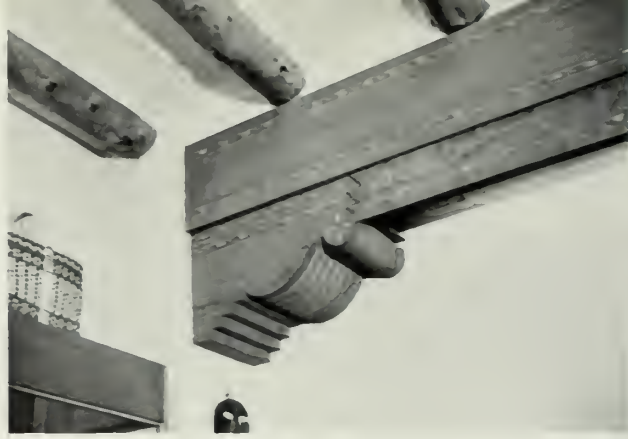
169

169. DETAIL OF DECORATIVE BEAM, CORBEL, AND CEILING, NORTH SALES AND DISPLAY ROOM (1023), ARTS AND CRAFTS SHOP, MAIN CORRIDOR, FIRST FLOOR. A one-by-six wood shield has been added to hide the strip of fluorescent tubes on the bottom side of the decorative beam between the corbels (*ejiones*). The rough plaster, slightly arched ceiling between the varnished logs (pine *vigas*) was designed to resemble adobe construction. Brooks Photographers, Bethesda, Maryland, 1976, HABS Collection.

Running from engaged pier to engaged pier, on the north and south walls, is a decorated beam; in each corner is a decorated corbel (*ejiones*, Fig. 169). The beam and corbel design consists of bullet shaped carved notches, inpainted with aqua blue and creamy-yellow paint. From a distance, the design on the beam appears like rows of sewing stitchery.

The beamed ceiling was adapted from an old Spanish mission at Cocospera, Mexico. The ceiling is constructed of plaster, with the existing beams being encased in wood (Fig. 169). The varnished wood beams retain the appearance of logs (pine *vigas*). The *vigas* vary from 6 to 8 inches wide and are spaced 2 feet on center. The plastered area between the *vigas* is slightly arched. The ceiling plaster has a painted finish, with uneven surface texture to resemble adobe.

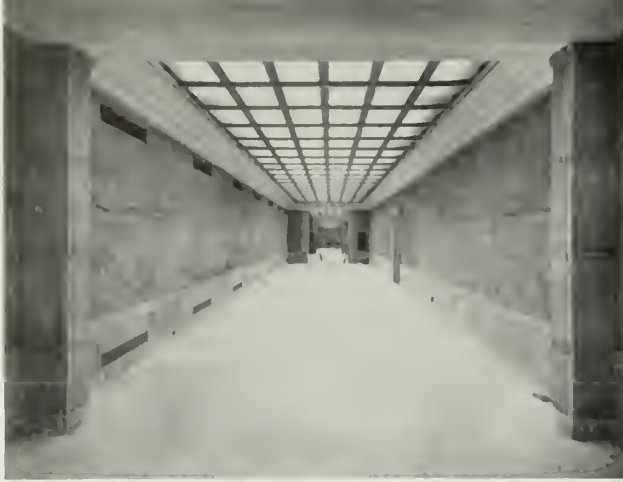
182

182. EAST GALLERY, WING 7100 EAST, SEVENTH FLOOR. View of the East Gallery looking west toward the Center Gallery. The original ceiling flooded the galleries with natural light. This photograph was taken in 1936 during the final phases of construction. Public Buildings Service, Photo No. 121-BCP-136A-10 in the National Archives, Washington, D.C. (A better photograph of the Fine Arts Gallery was published in the March 1939 issue of *School Life* (Vol. 24, Issue 6) in an article by Walter J. Greenleaf entitled "Fine Art and Colleges" (pages 179 and 184).

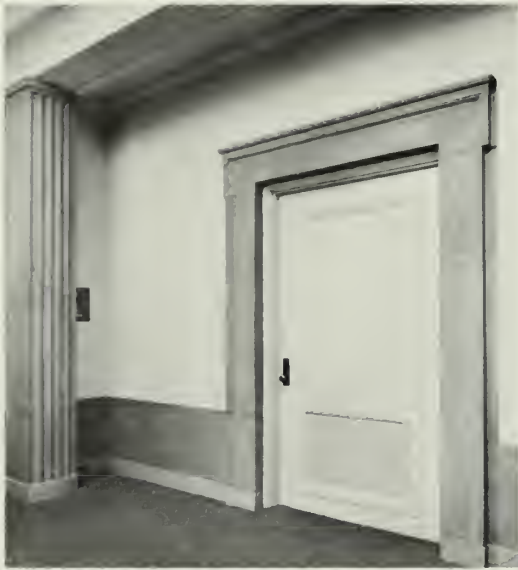
184

184. MONUMENTAL DOOR, WEST GALLERY, WING 7100 WEST, SEVENTH FLOOR. The doors facing the Galleries have limestone surrounds with crosstressed corners and cornices. The portals between Galleries and the alcoves at the ends of the Galleries are flanked with fluted limestone pilasters. Brooks Photographers, Bethesda, Maryland, 1976, HABS Collection.

hard plaster classical cornice, a limestone wainscot, and a marble base and plinths. Walls originally had cork tile which was covered with cloth. The engaged fluted pilasters are limestone. The pilasters do not have capitals and the pilaster front has a slight convex curve (Fig. 184). Unfortunately, some of the new walls were butted up to the pilasters. Offices along Courts A and E have a birch chair-rail instead of limestone wainscot. Bases are Tennessee gray marble (6 inches high).

The doors facing the Galleries were given a monumental treatment (Fig. 184). They still have their limestone surrounds with crossetted corners and classical cornice. The painted birch doors have raised panels with beveled edges and molded stiles and rails. The lower panel to the storage area has louvers. The rail between the panels is fluted. The panels are surrounded by a border of four raised beads.

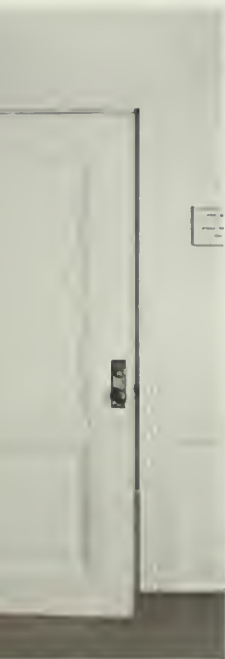
186

185. TYPICAL DOOR, ROOM 7000E, WING 7100 WEST, SEVENTH FLOOR. The typical door in the area of the support rooms for the former Art Gallery have a beaded border around the panels and between the panels a fluted rail that matches the fluted door surrounds. The corner blocks have concentric squares. Brooks Photographers, Bethesda, Maryland, 1976, HABS Collection.

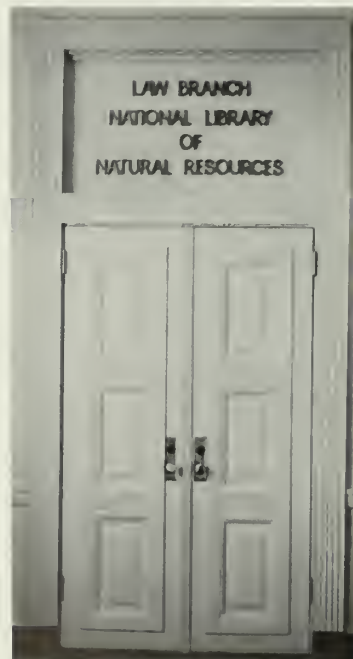
186. DOUBLE DOORS TO THE LAW BRANCH OF THE NATIONAL LIBRARY OF NATURAL RESOURCES, ROOM 7138, WING 7100 WEST, SEVENTH FLOOR. Unfortunately, when the door was heightened, the matching corner blocks were not reinstalled (see Fig. 184). Brooks Photographers, Bethesda, Maryland, 1976, HABS Collection.

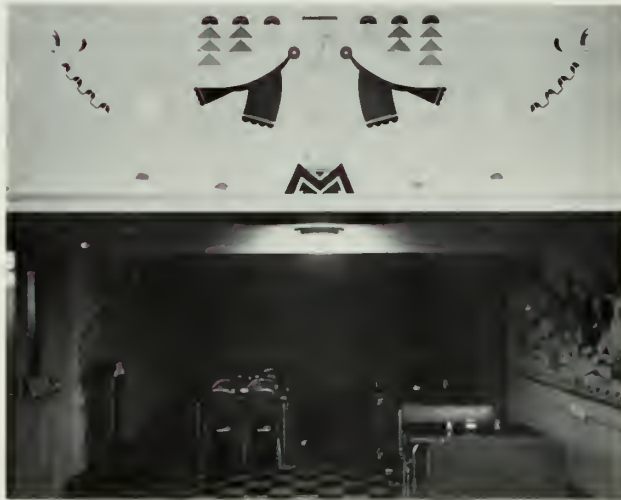
189

188. EMPLOYEES' LOUNGE, SOUTH PENTHOUSE, EIGHTH FLOOR. View of Employees' Lounge looking north toward the north annex which had a soda fountain. The lounge was used for coffee breaks and as a brown bag lunchroom. The photograph was taken before 1940 when the Indian murals were painted. Note that the hanging light fixtures are very similar to those backstage at the Auditorium (Fig. 147). Public Buildings Service, Photo No. 121-BCP-136A-26 in the National Archives, Washington, D.C.

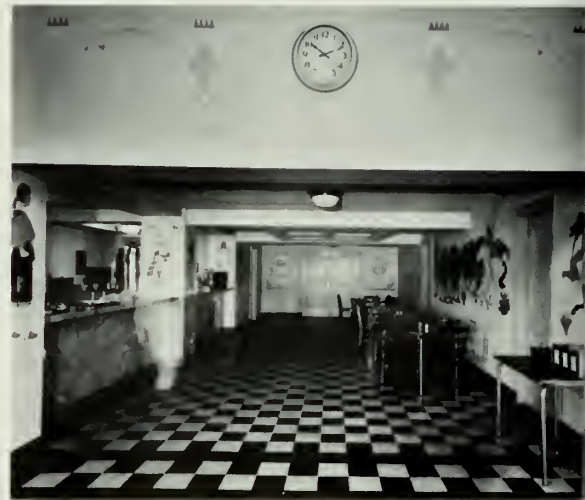
190

189. SOUTH ANNEX OF EMPLOYEES' LOUNGE, SOUTH PENTHOUSE, EIGHTH FLOOR. Access to the South Penthouse is by Stairs J from Wing 7200 East (the elevators do not service the penthouses). On the left is the double doors leading to Stairs J and in the shadows are the double doors to the room south of the south annex. Public Buildings Service, Photo No. 121-PS-4843 in the National Archives, Washington, D.C.

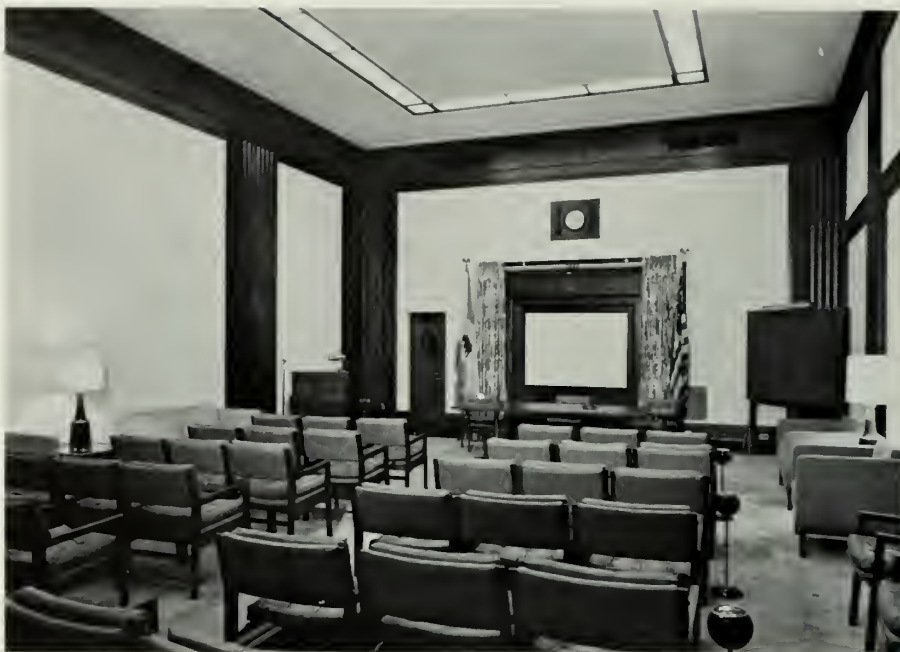
198

198. MAIN STUDIO (LOOKING NORTHWEST), NORTH PENTHOUSE, EIGHTH FLOOR. The ceiling of the studio is two stories high. The windows to the Visitors' Gallery in the upper section of the west wall have been covered with acoustical tile. On the far right is the main entrance to the studio. Brooks Photographers, Bethesda, Maryland, 1976, HABS Collection.

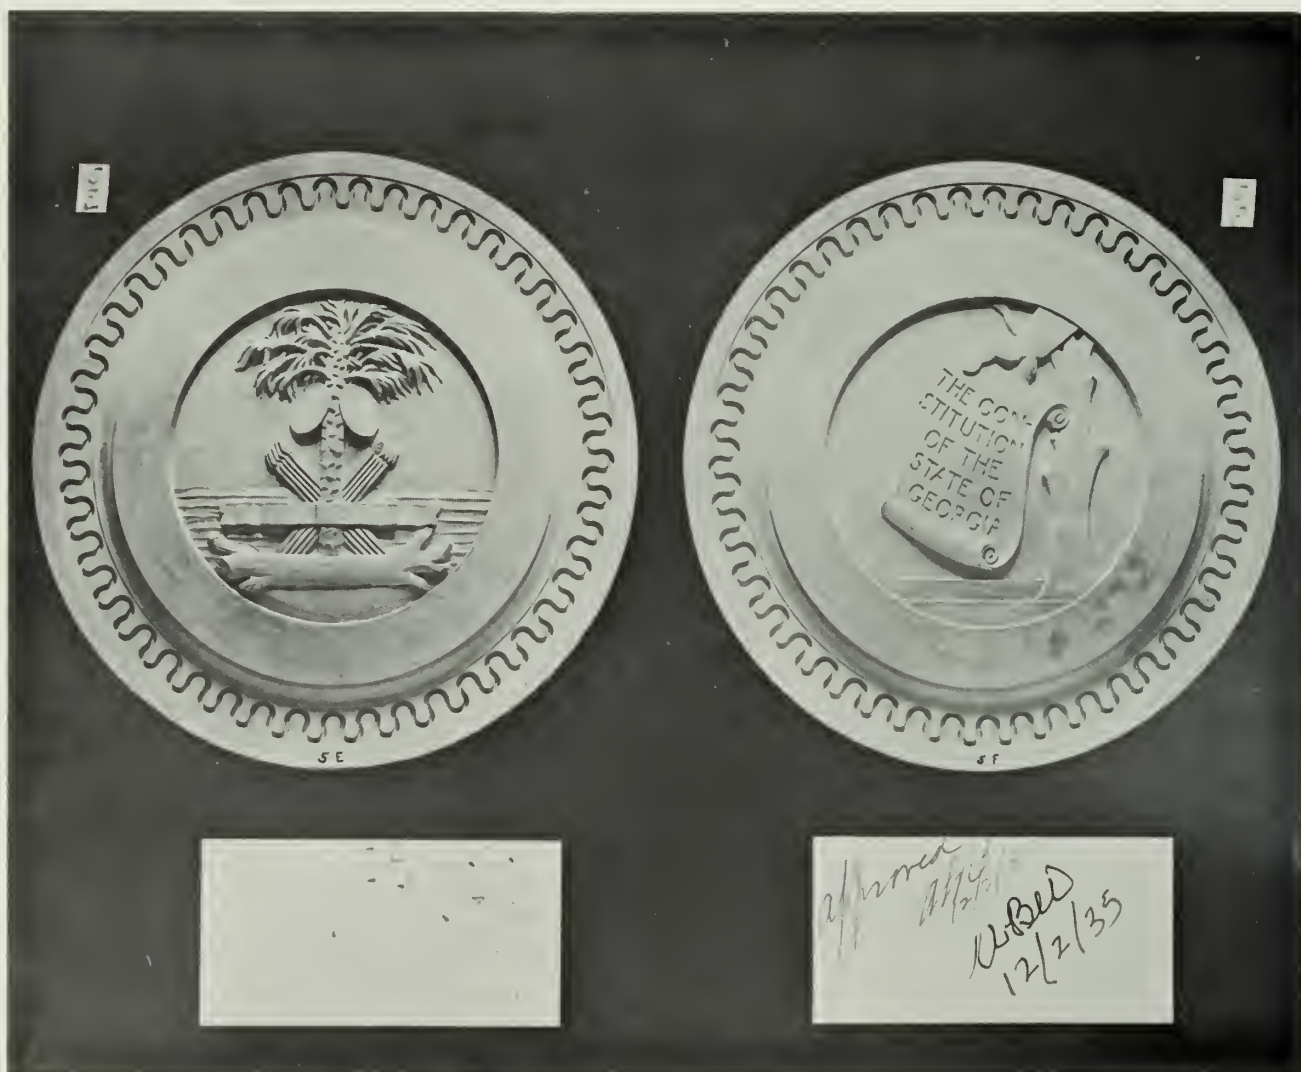
271. MODELS 5E AND 5F. The frieze on the attic of the south elevation (C Street façade) of the Interior Building (Figs. 13 and 21) consists of 13 round seals, one of each of the thirteen original colonies. Full-size plaster bas-relief models were executed by A. Bussard and Company, Plastering Contractors of Sculpture and Decorations, Washington, D.C. The photographs of four of these models have survived in the Public Buildings Service Collection in the National Archives. Models 5E and 5F are the seals representing South Carolina and Georgia, respectively. Each design has an incised serpentine border and a flat band

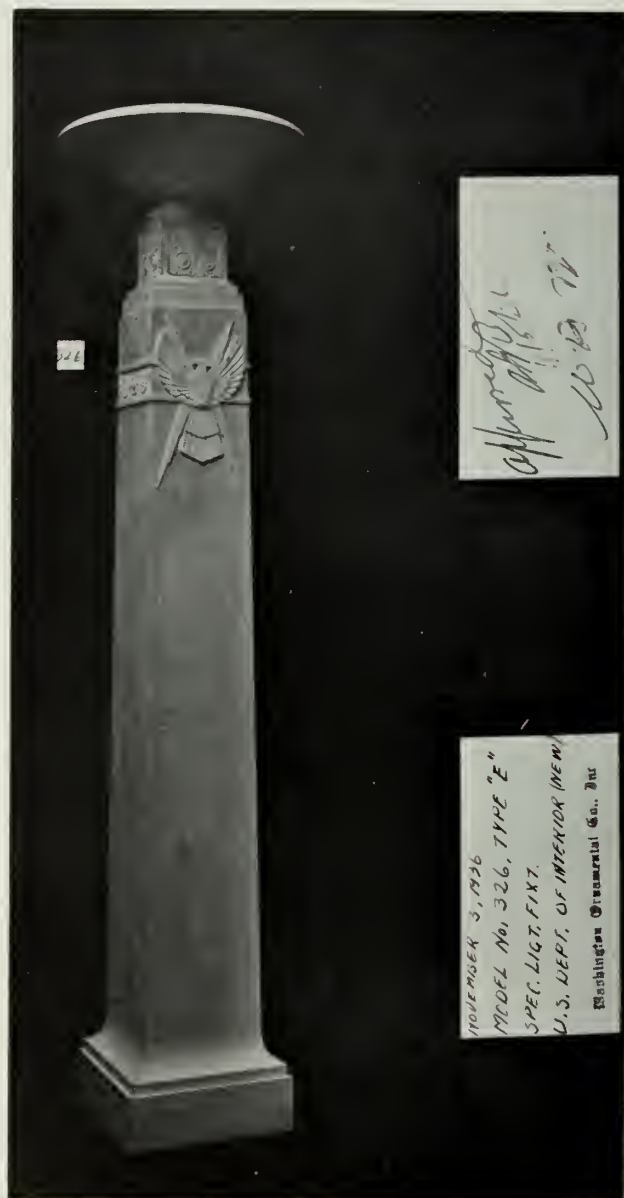
272

272. MODEL 326, TYPE E. Tall, free-standing floor lamps were specially designed for the South and North Lobbies. Eight lamps stood flanking the center bay of each wall (see Fig. 41) until they were removed during the remodeling of the entrances in 1970. The white alabaster urn held a lamp directed toward the ceiling. The square bronze base of the urn has an anthemion design on each side. The granite pylon has a stylized eagle and lightning bolts on the front side and a band of floral ornamentation between the fillets on the other sides. This eagle motif is also found on the escutcheon plates of the buffalo door-knobs (see Figs. 287 and 289). The bottom of the pylon has a congé above the square base. The plaster model for these lamps was executed by Washington Ornamental Co., Inc. Public Buildings Service, Photo No. 121-BS-102D-10 in the National Archives, Washington, D.C.

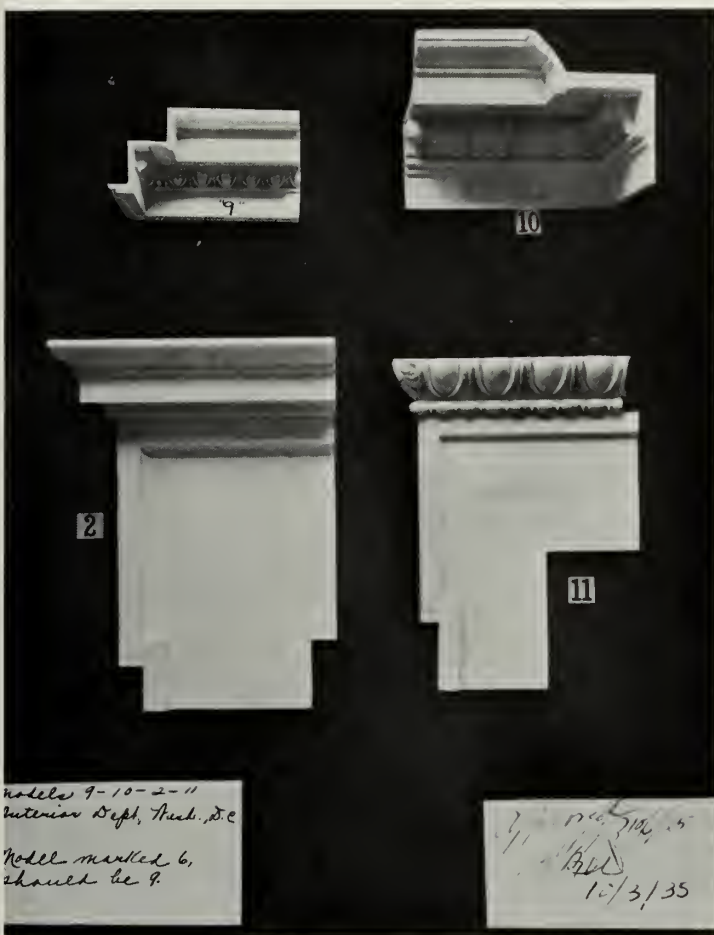
273

273. MODELS 9, 10, 2, AND 11. These four models are of details at the south entrance. Model 9, the plaster ceiling cornice in the South Vestibule (see Fig. 33), consists of an egg-and-dart molding supporting a corona with a drip and crowned by an echinus-and-scotia molding. Model 10, the plaster ceiling cornice in the South Lobby (see Fig. 40), has a Doric molding and bead supporting a corona with a drip and crowned by an echinus-and-bead molding. Model 2, the plaster model for the granite exterior door treatment at the south entrance (see Fig. 15), features a crosssetted door surround with a congé edge below a cor-

nice consisting of a cyma recta molding supporting a corona with a drip and crowned by an echinus molding. Model 11, the marble door treatment in the South Lobby (see Fig. 39), consists of a crosssetted door surround with a congé edge and crowned by a cornice of an egg-and-dart molding above a bead-and-reel. Public Buildings Service, Photo No. 121-BS-102D-5 in the National Archives, Washington, D.C.

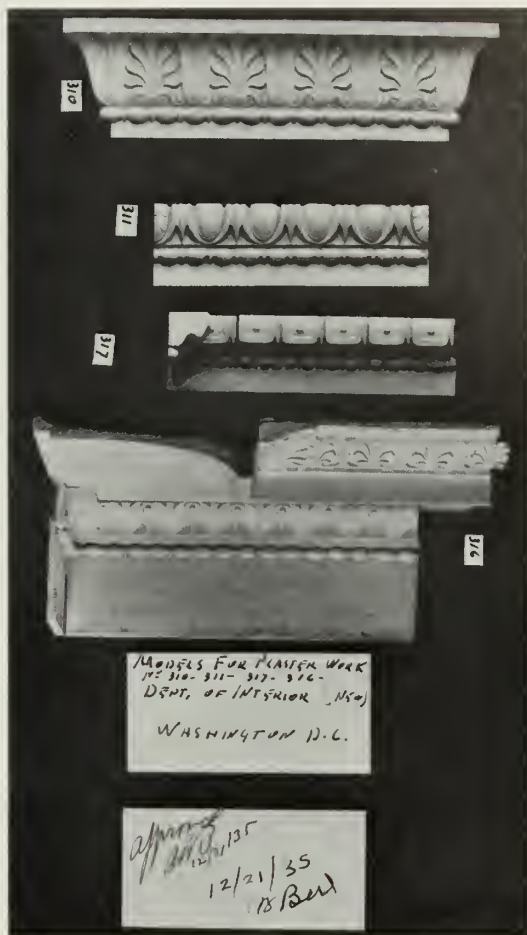
274

274. MODELS 310, 311, 317, and 316. Model 310, a stylized anthemion band above a bead-and-reel, is the plaster capital of the pilasters and piers in the Auditorium (Conference Hall, Fig. 139). Model 311, a plaster egg-and-dart molding above a bead-and-reel, is the crown molding above the frieze of State seals and below the blind gallery in the Auditorium (see Fig. 141). Model 317, a Doric molding (profile of an ogee below an echinus) above a bead-and-reel, is the ceiling molding in the galleries overlooking the Reading Room in the Library (see Figs. 157 and 158). Model 316, the ceiling cornice in the Library Reading Room (see Fig. 159), consists of a leaf-and-dart molding (cyma reversa profile) above a bead-and-reel supporting a wide, shallow corona with an underthroat forming a reverse cove and crowned by an anthemion band (cyma recta profile). Public Buildings Service, Photo No. 121-BS-102D-6 in the National Archives, Washington, D.C.

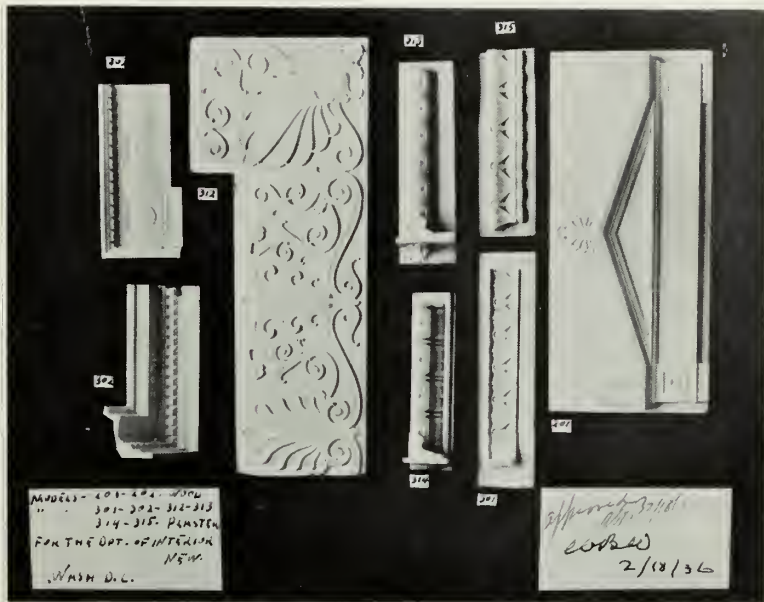
275

275. MODELS 302, 202, 312, 314, 313, 301, 315, and 201. This collection of plaster and wood models features details from several locations within the Interior Building. Model 302, the ceiling cornice in the South Foyer (see Fig. 42) consists of a dentil molding above an inverted stylized water leaf molding (cyma recta profile), supporting a corona with a drip, and crowned by a composite molding of an echinus above a scotia. Model 202, the wood soffit in

Room 5108 (see Fig. 99), consists of square recessed panels with a recessed five-pointed star inscribed within a circle and with a cyma recta molding border. These panels alternate with reeded sections. The corner panel has a bas-relief rosette instead of a star. The soffit is bordered along the wall by a simple running Greek fret design above a cyma reversa molding and along the ceiling by a cavetto-and-bead molding. Model 312, a stylized anthemion band embellished with flowers and scrolls, is the ornate plaster border of the large center panel of the Auditorium (Conference Hall) ceiling (see Fig. 146). Models 314 and 313 are similar to Model 317, but are of slightly different profile and scale. Model 314, a Doric molding above a bead, is the molding around the ceiling of the nave of the Auditorium (see Fig. 137). Model 313, a smaller scale Doric molding, is the border around the square ceiling bays of the Auditorium side aisles (see Fig. 142). Model 301, the ceiling molding in the South Lobby (see Fig. 40), is a leaf-and-dart molding with a bead-and-reel around it. Model 315, a leaf-and-dart molding (cyma reversa profile) above a bead-and-reel, is a plaster molding over some of the doors in the waiting room of the Broadcasting Studio in the North Penthouse. Model 201, the classical wood door cornice in Suite 5116 (see Fig. 97), consists of a lintel with corner blocks of concentric squares surmounted by a triangular pediment with anthemion antefixae. The horizontal and raking cornice have a cavetto molding supporting an echinus and fillet molding. Public Buildings Service, Photo No. 121-BS-102D-7 in the National Archives, Washington, D.C.
